Manhole Inspection Summary

Manhole # S29CC1024MH

Insp Date: **6/1/07 12:58 PM**

Location Address: **720 36TH ST**

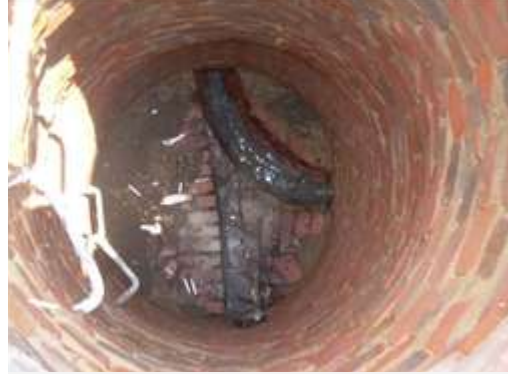
Top View

Evidence of surcharge - Bench debris.
Channel debris.

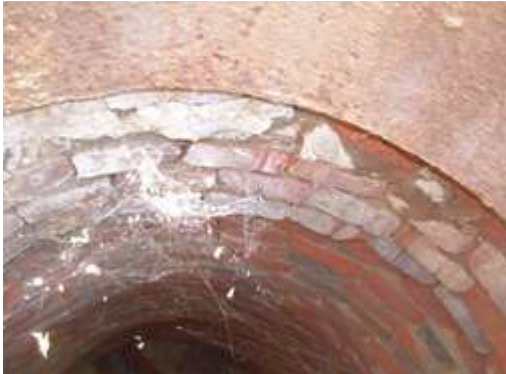
Defect

Frame Offset: **2** (in.) Condition: ☐ Sound ☐ Cracked ☒ **Leaks**

Condition: ☐ Sound ☐ Cracked ☐ Root Intrusion ☐ Loose Brick ☒ **Deteriorated**

Infiltration: ☐ None ☒ **Joint** ☐ Cracks ☐ Mortar ☐ Roots ☐ Wall

Frame leaks. Corbel deterioration and
infiltration.

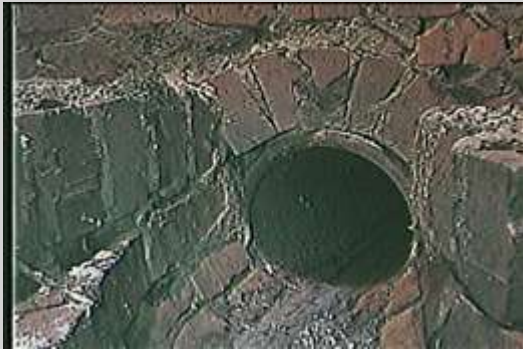
8 in. Circular Gravity Sewer Pipe Out @ 12 O'Clock

Barrel deterioration and infiltration. Channel deterioration.

Infiltration: **Evidence** Pipe Seal Cond: **Cracked**

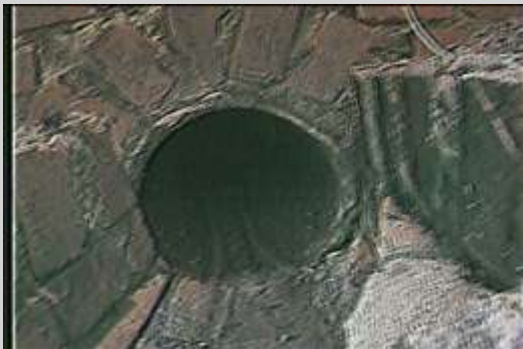
8 in. Circular Gravity Sewer Pipe In @ 3 O'Clock

Channel deterioration and debris.

Infiltration: **Evidence** Pipe Seal Cond: **Unknown**

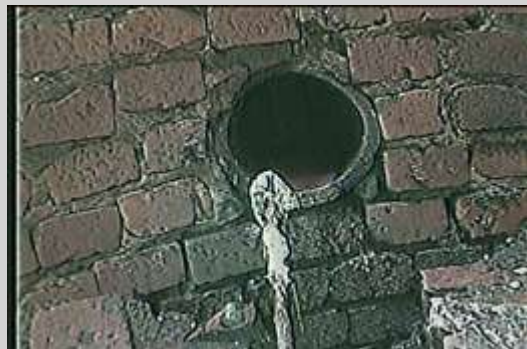
6 in. Circular Gravity Sewer

Barrel deterioration and infiltration.

Infiltration: **Evidence**

Pipe Seal Cond: **Cracked**
